This document is intended to explain the function and importance of the M14/M1A firing pin safety bridge. This is merely an informative article which requires no tools.

The Safety Bridge: What it is, and why it's so important...

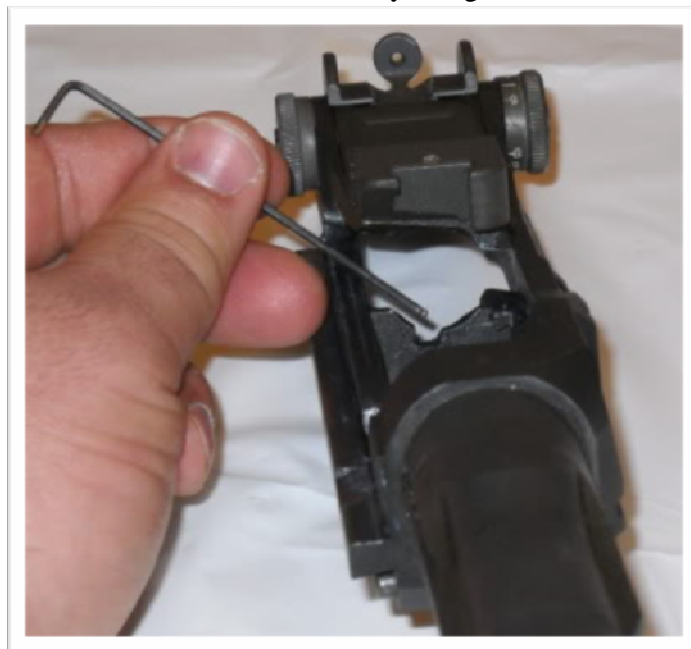
Just above the magazine latch, there is a groove in the area of metal just below the bolt that we call the "Safety Bridge". The M1 Garand and the M14 designs use a free-floating firing pin inside the bolt. If the firing pin channel is clogged or dirty, the firing pin may jam up, protruding from the face of the bolt.

This is the safety bridge...

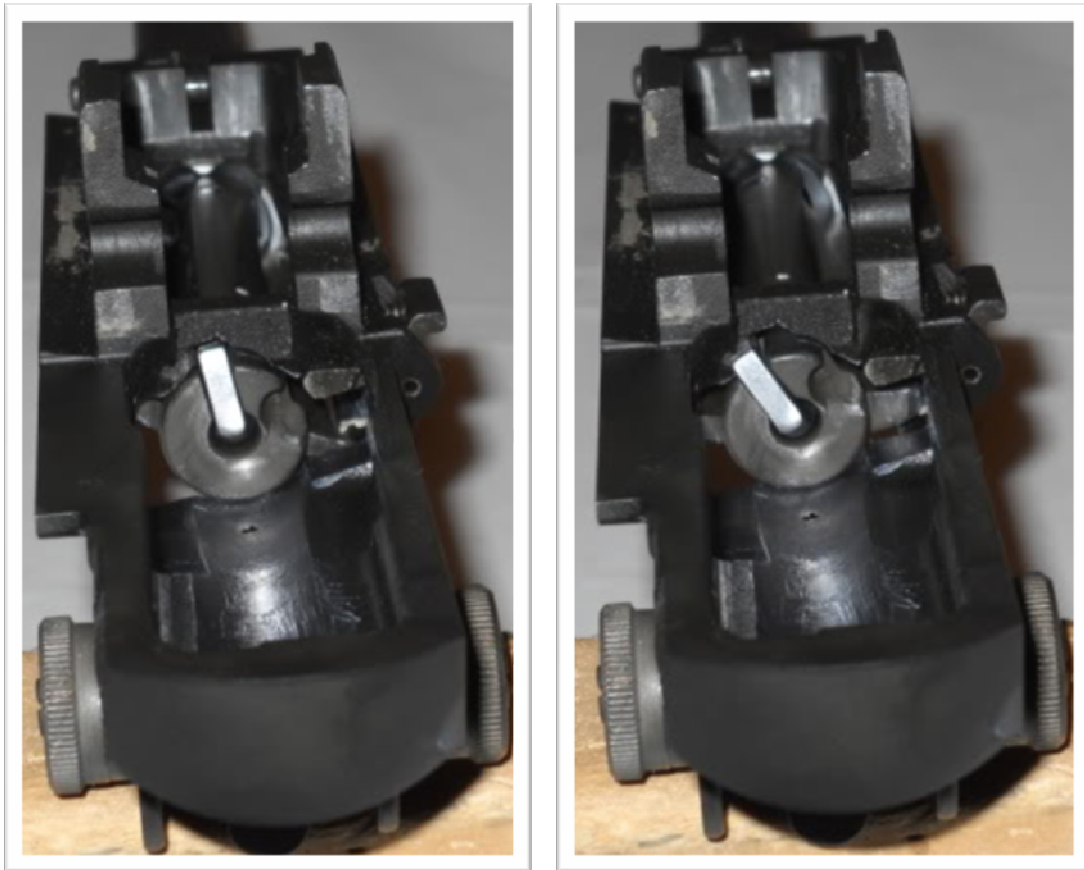
When the bolt is fully engaged into the bolt lug recesses, the firing pin will line up with the slot in the safety bridge allowing the firing pin to move forward and strike the primer.

Left image: bolt fully engaged; firing pin free to strike the primer. Right image: bolt fully forward but not engaged; firing pin blocked by the safety bridge.

If the bolt is not fully engaged, the firing pin will be blocked by the safety bridge and prevent a premature detonation of the unchambered cartridge.
